1. AGENCY USE ONLY (Leave blank)	2. REPORT DATE 1996	3. REPORT TYPE AND DATES COVERED Final Report		
4. TITLE AND SUBTITLE The Old Hospital Complex (5EP1778) Fort Carson, Colorado		5. FUNDING NUMBERS

13. ABSTRACT (Maximum 200 words) <p>The Old Hospital Complex (5EP1778) at Fort Carson, Colorado, consists of 59 buildings. The Complex was built during World War II and is significant due to its association with the history of the United States. The complex is semi-permanent construction, constructed from the Department of the Army's Series 800 plans. This report documents the complex in accordance with Section 1(g) of the Memorandum of Agreement enacted among the Department of the Army, Headquarters Fort Carson, the Colorado State Historic Preservation Office, and the Advisory Council on Historic Preservation.</p> <p style="text-align: center;">DTIC QUALITY INSPECTED 2</p>

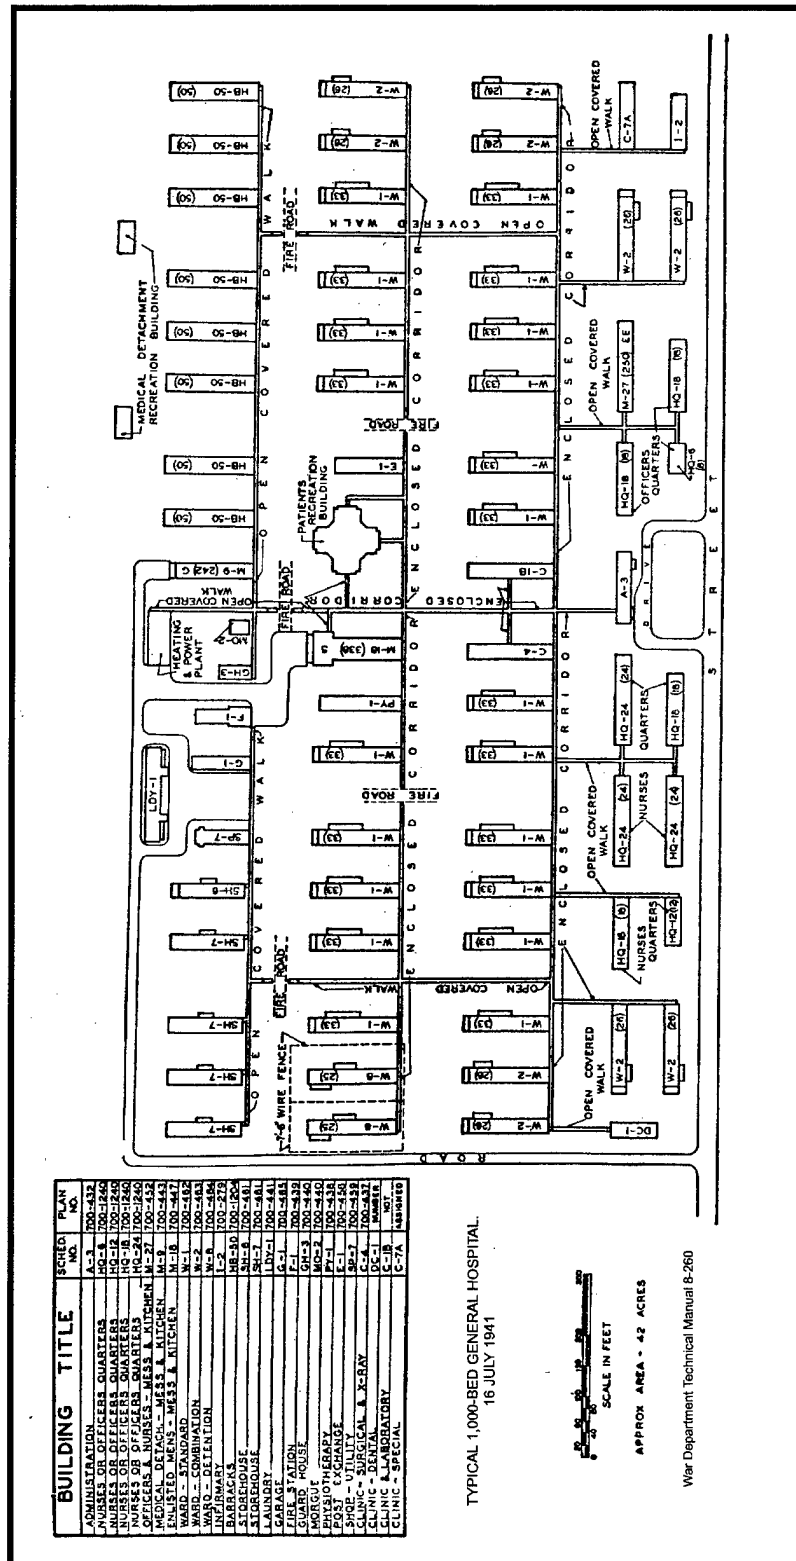
Figure II.1 Typical general hospital layout from 1941 technical manual (War Department 1941).

The general guidelines in 1941 for locating and establishing a general hospital can be found in the Technical Manual for Fixed Hospitals of the Medical Department (War Department 1941). The manual shows a typical layout for a 1,000-bed general hospital, which was to be suited to local conditions and needs (Figure II.1). In general, a 1,000-bed general hospital would have 62 buildings: 33 wards, administration, surgical, receiving and forwarding, and bath buildings, messes, and personnel buildings. The manual specifies three types of wards:

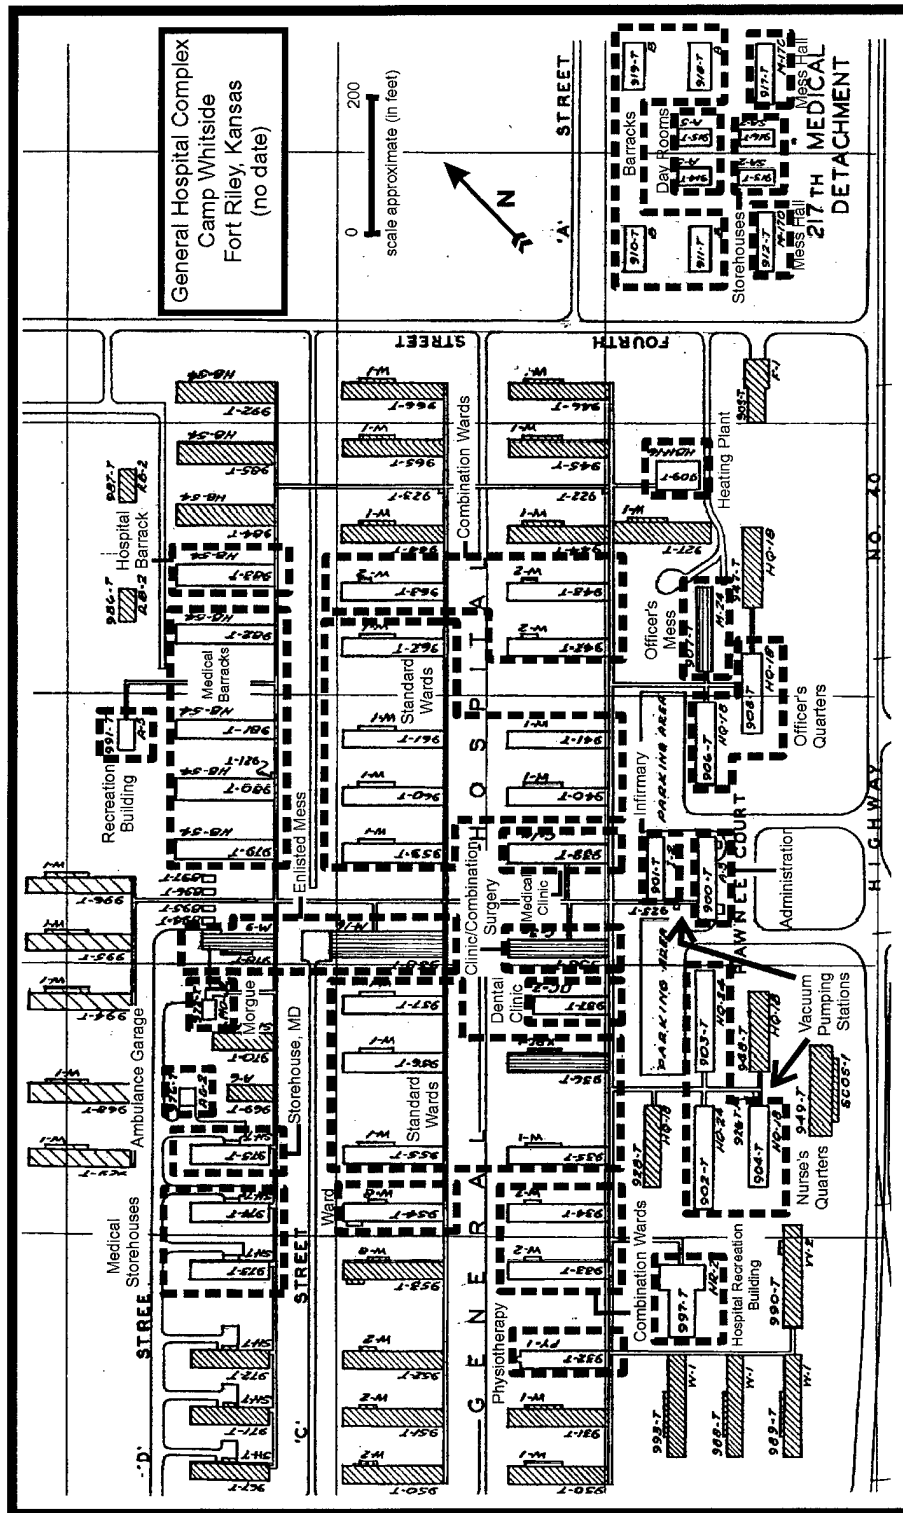
Figure II.2 Fort Riley hospital layout.

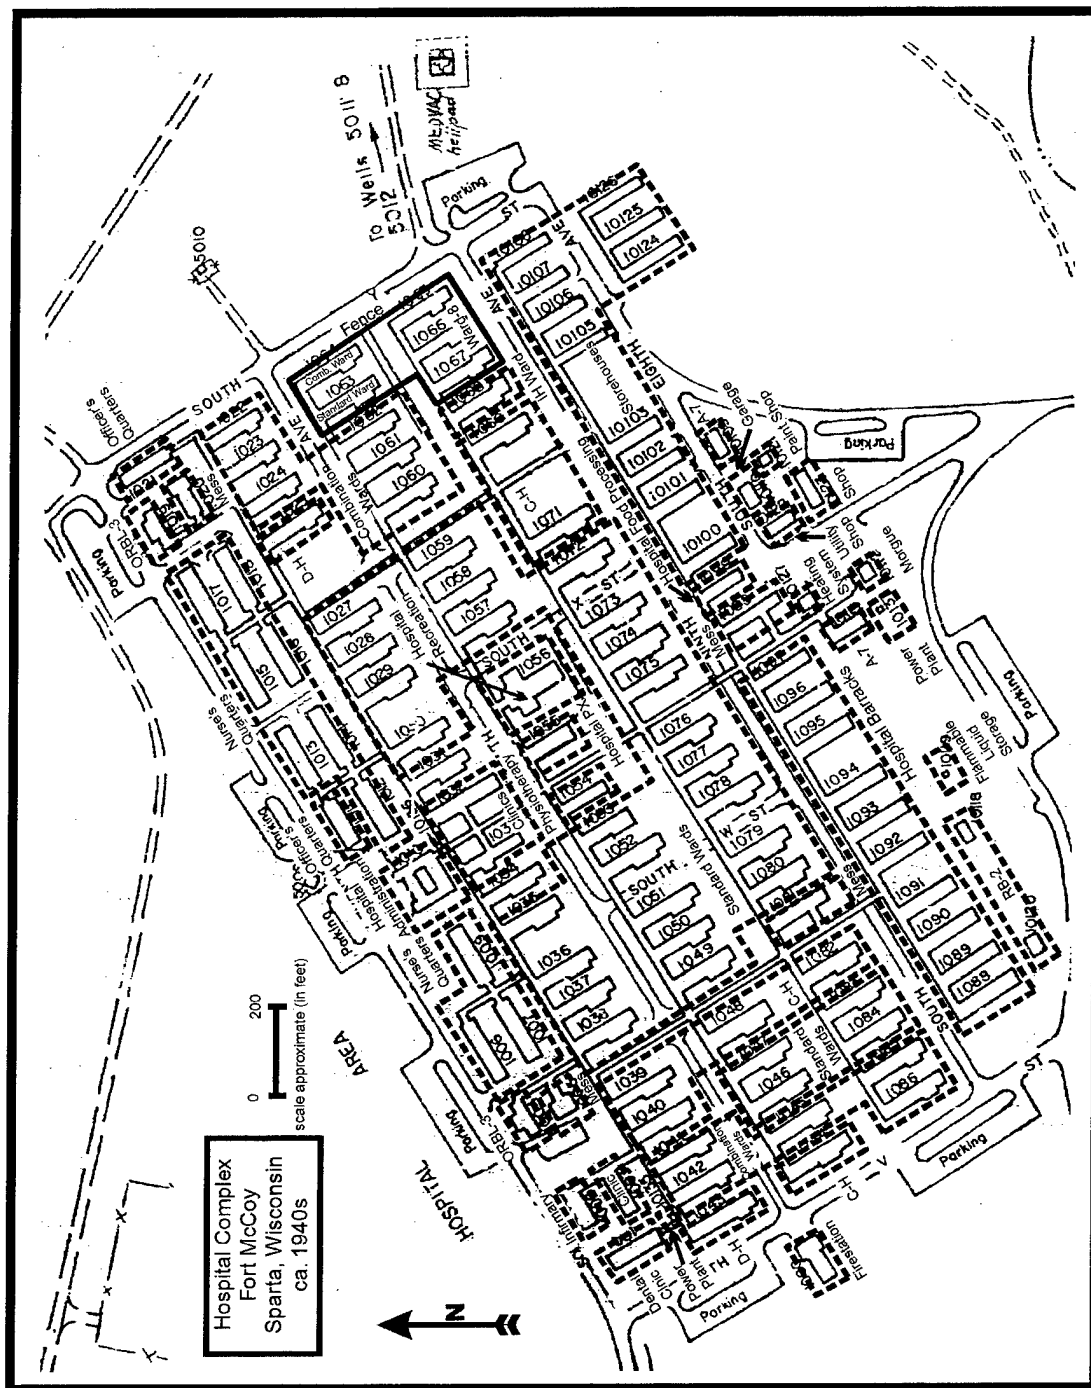
Figure II.3 Fort McCoy hospital layout.

Fort McCoy did not send information on individual buildings. An undated map of the complex shows the layout, and a list of building types allowed us to compile Figure II.3. Note the fire station on the west side of the complex and the fire roads that run throughout the complex. Both suggest that the buildings were wooden and the possibility of fire was a major concern. In general, however, the hospital flow and layout strongly resemble the proposed layout in the 1941 technical manual. The officers' and nurses' quarters are in the front of the compound, the medical services are in the center of the compound, the wards are to the sides of the medical services, the medical detachment barracks and mess are to the rear of the wards, and the utilities and support services are to the very rear of the compound. An infirmary, clinic area, and dental clinic are on the northwest corner of the compound, rather than in the center as they should be from the proposed plan. This, however, plus the addition of the fire station, constitute the major departure from the proposed plan.

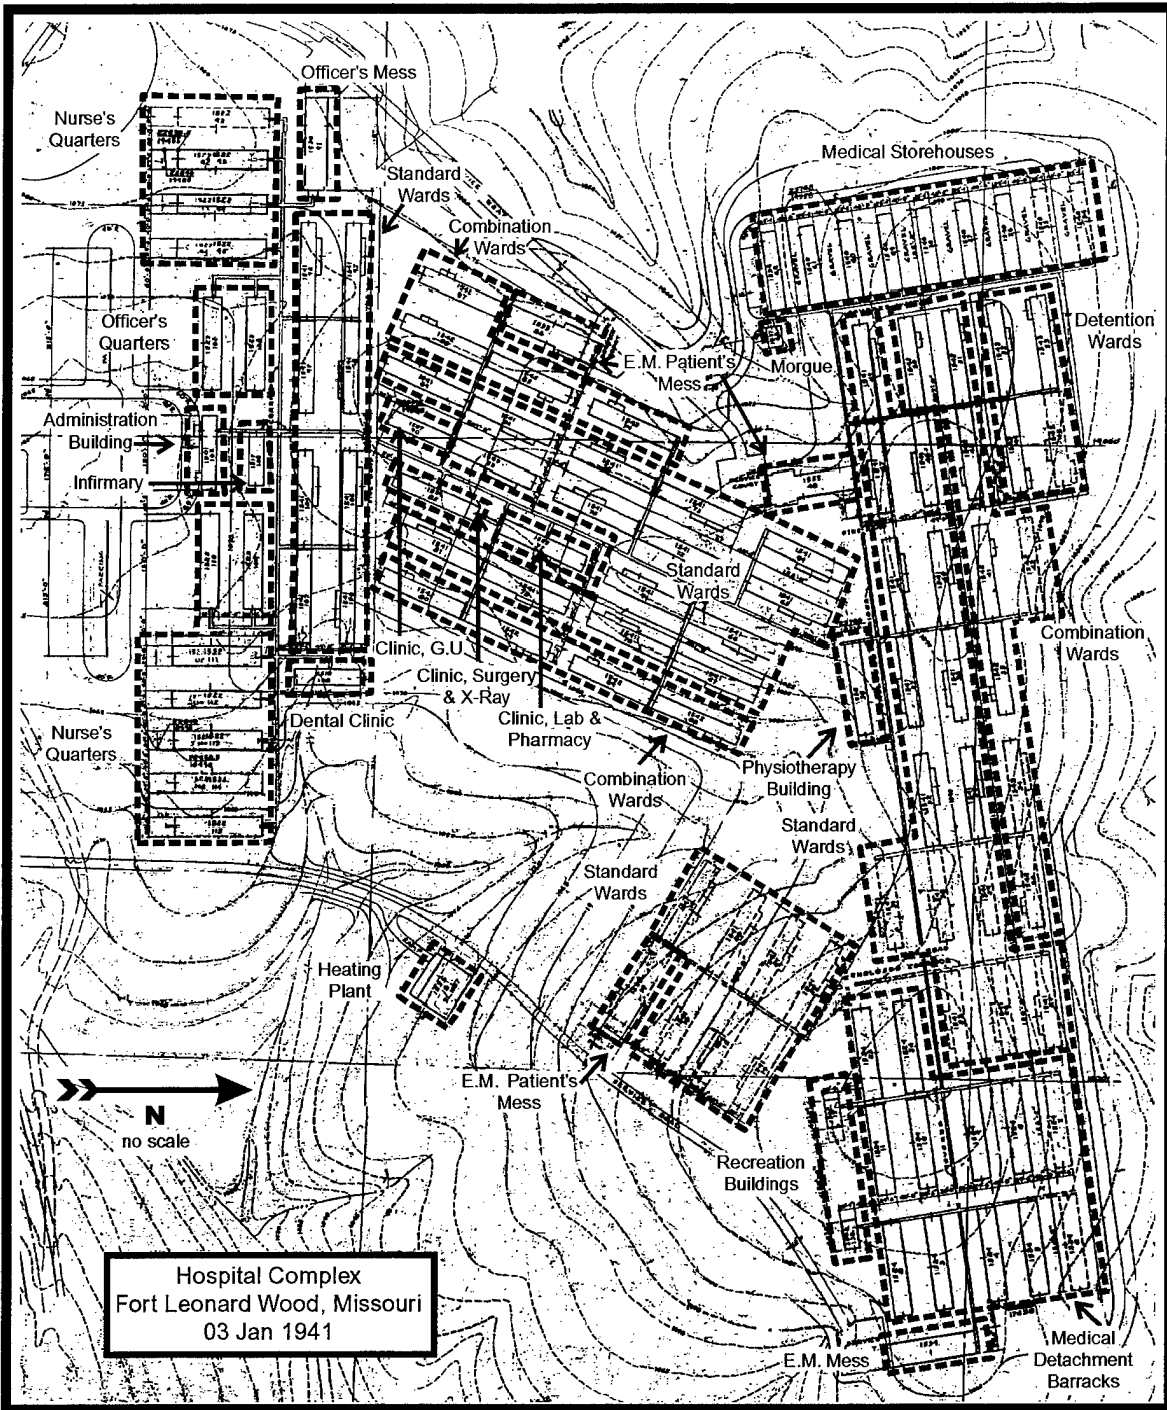
Figure II.4 Fort Leonard Wood hospital layout, January, 1941 plans.

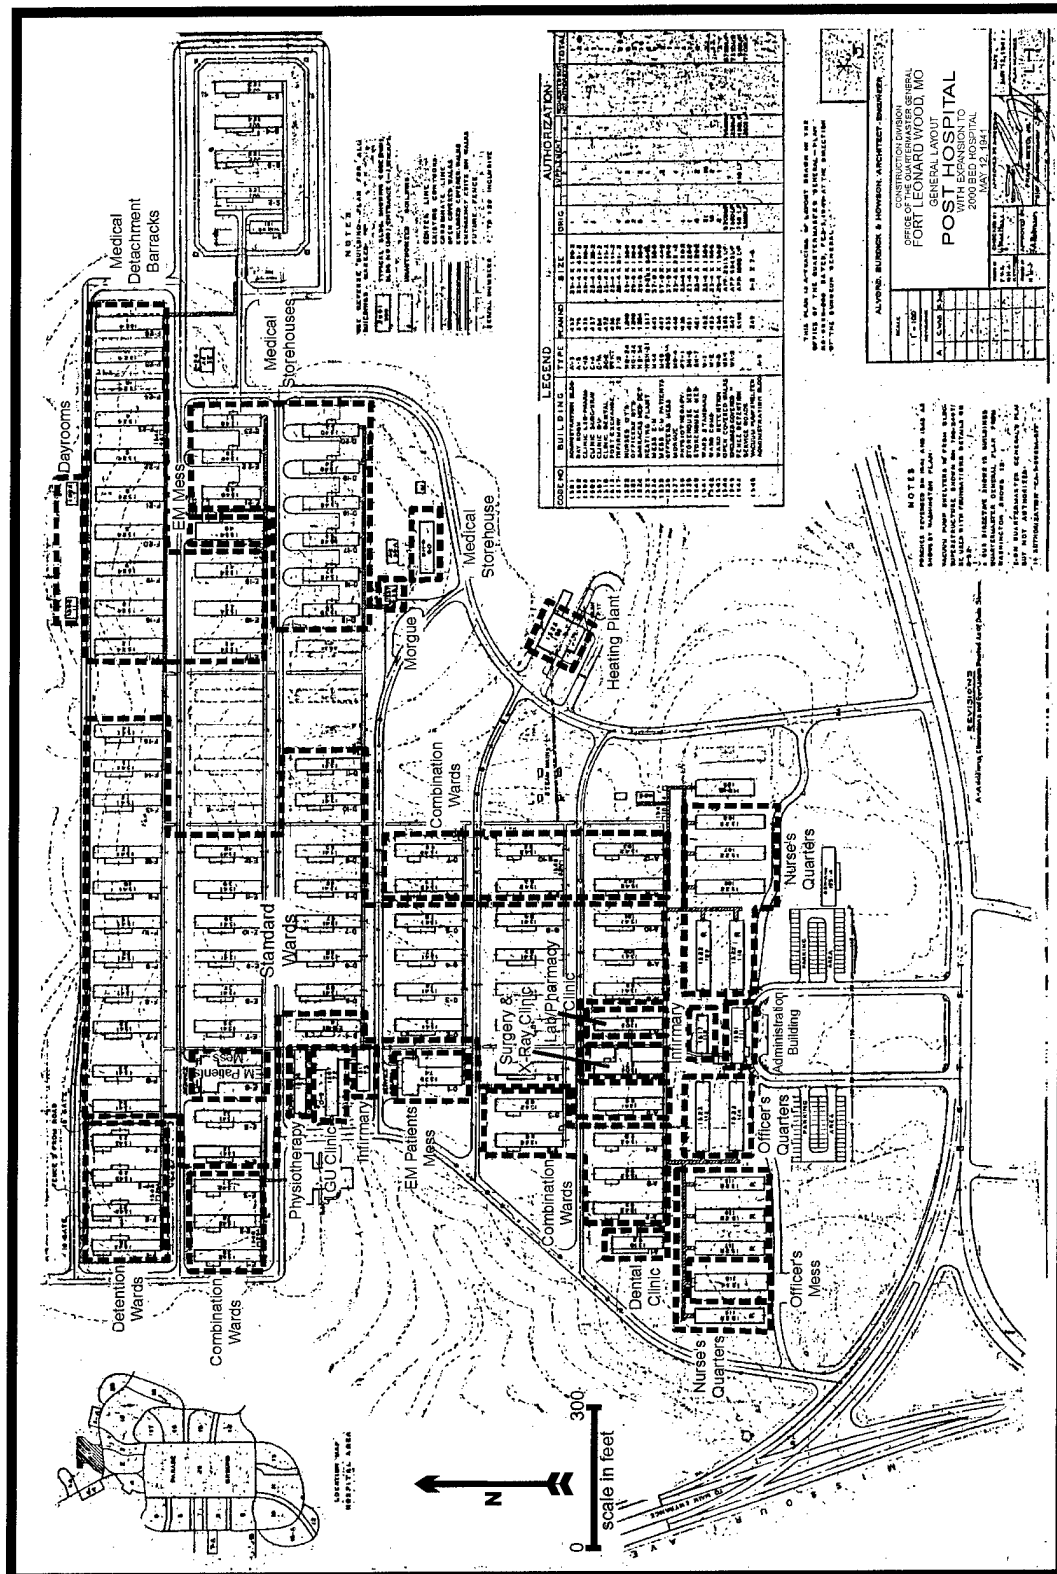
Figure 11.5 Fort Leonard Wood hospital layout, May, 1941 plans.

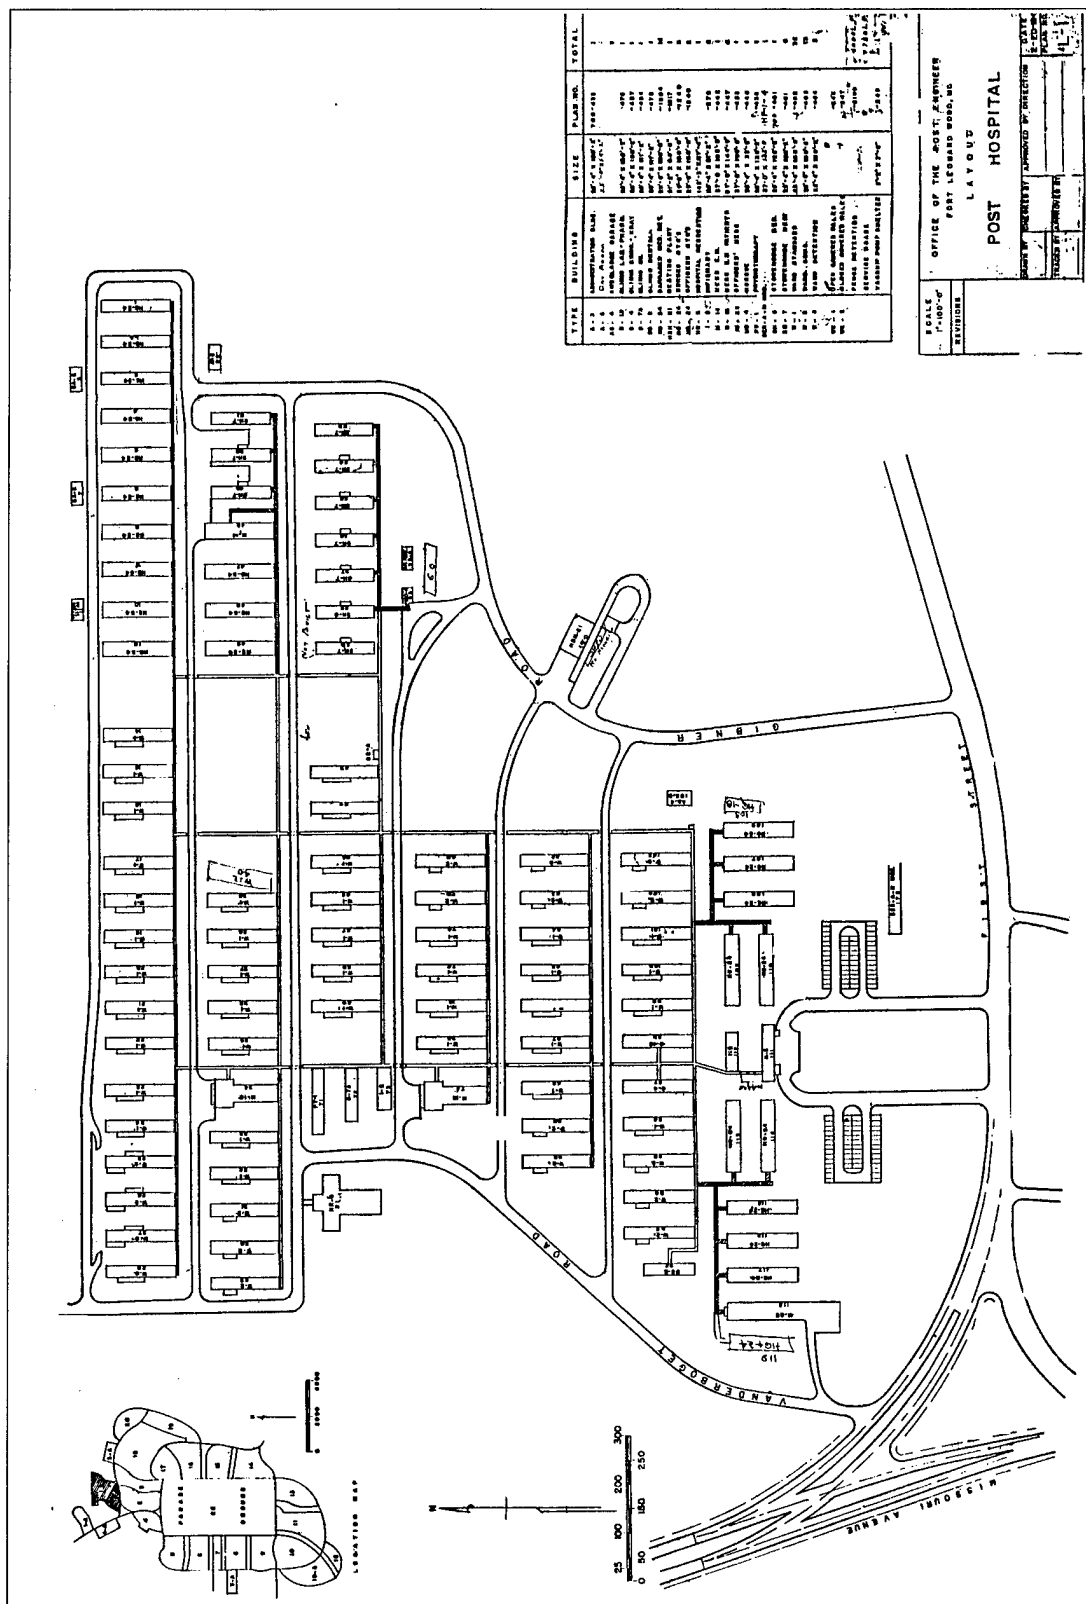
Figure II.6 Fort Leonard Wood hospital layout, February, 1943 plans.

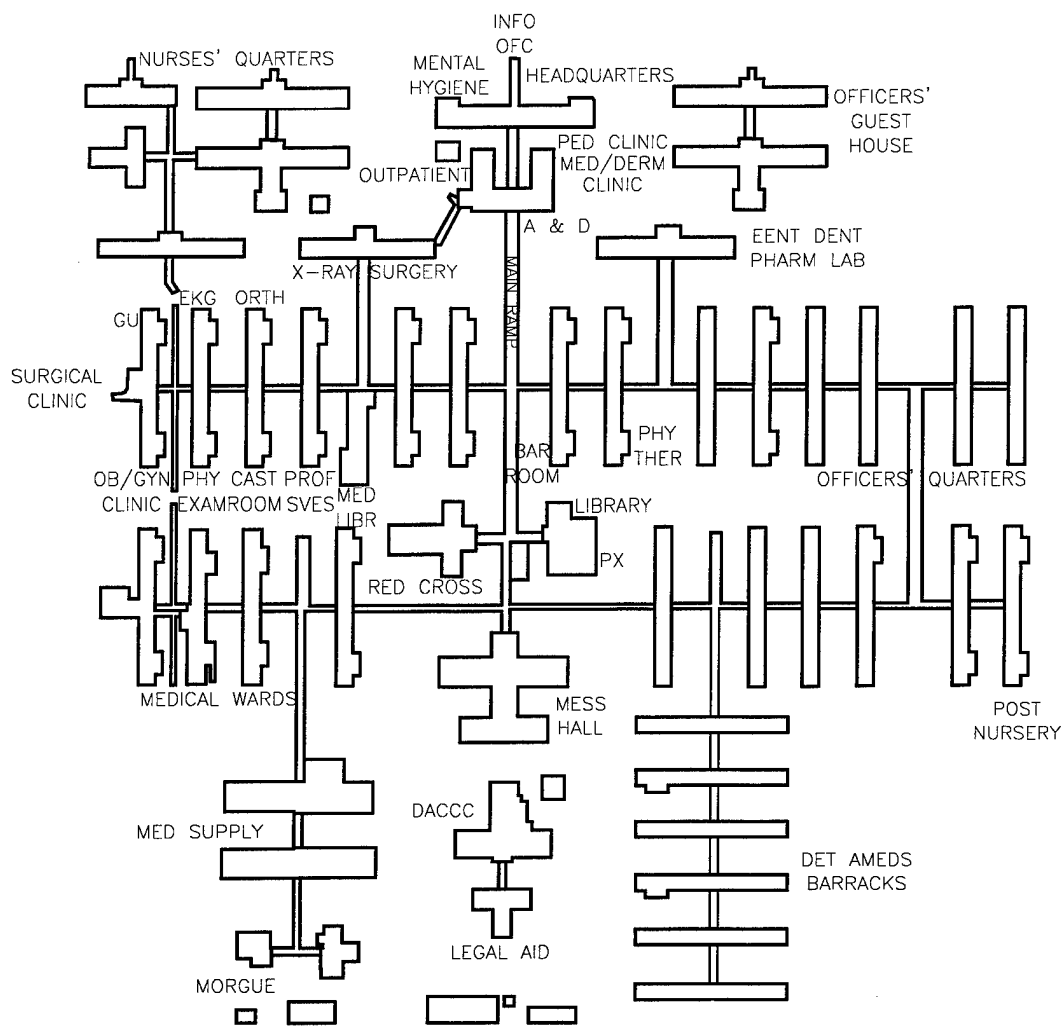
Fort Carson Old Hospital Complex
Historic Building Functions (no date)

Figure II.7 Fort Carson general hospital. Undated plans.

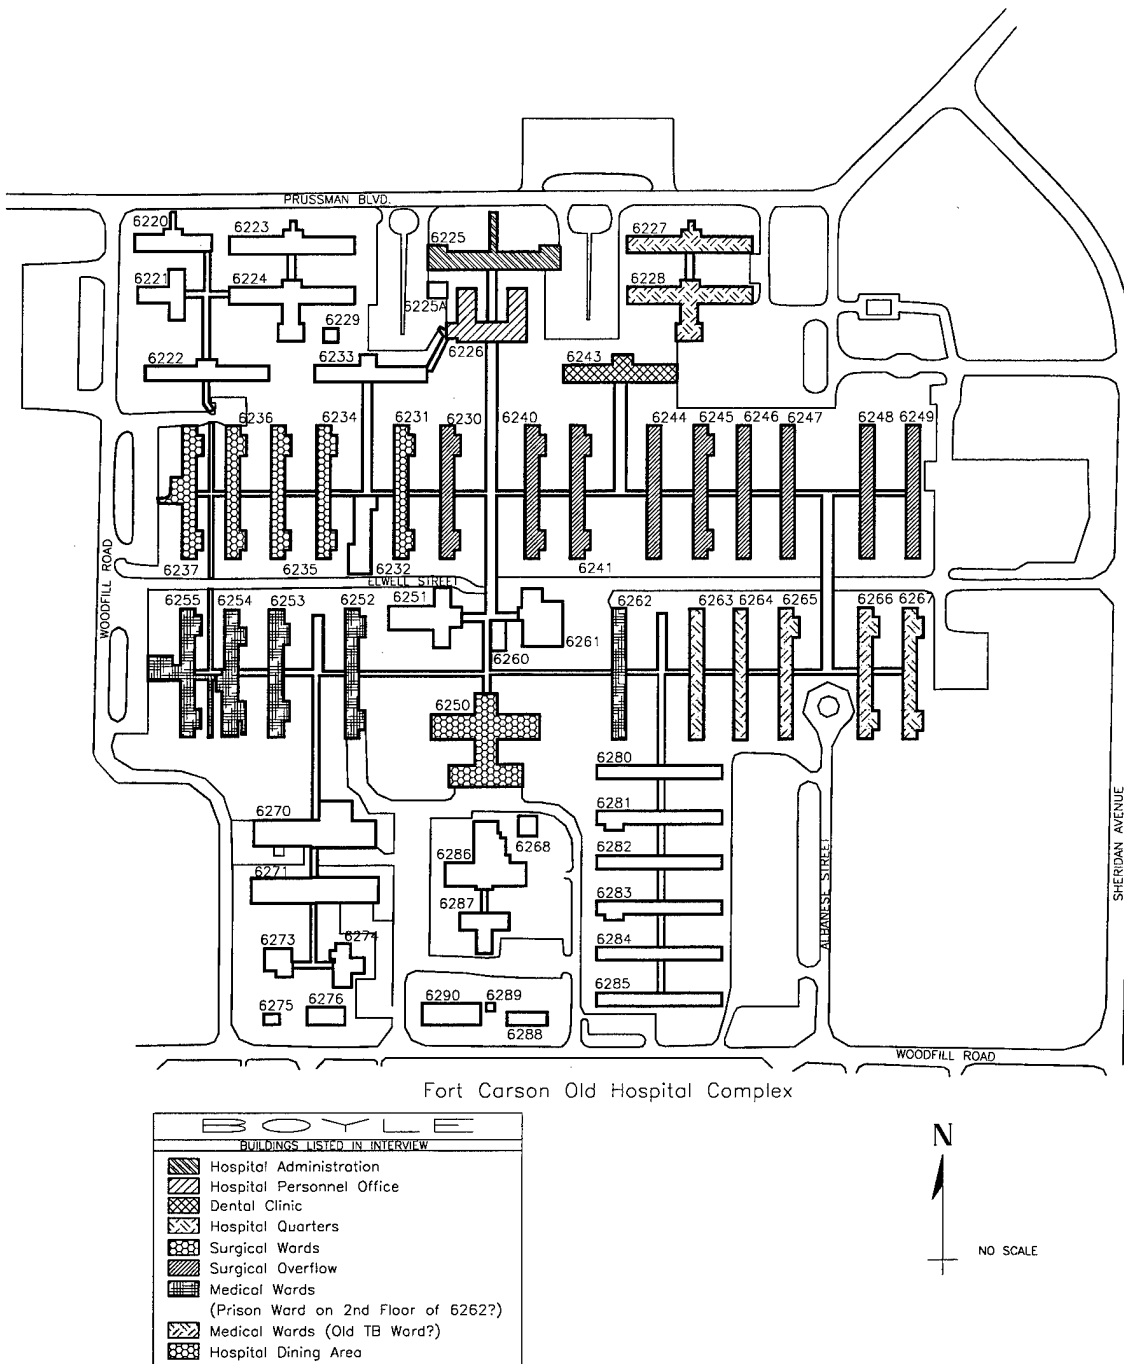
Figure II.8 Camp Carson general hospital. Building functions remembered by Boyles (personal communication, 1996).

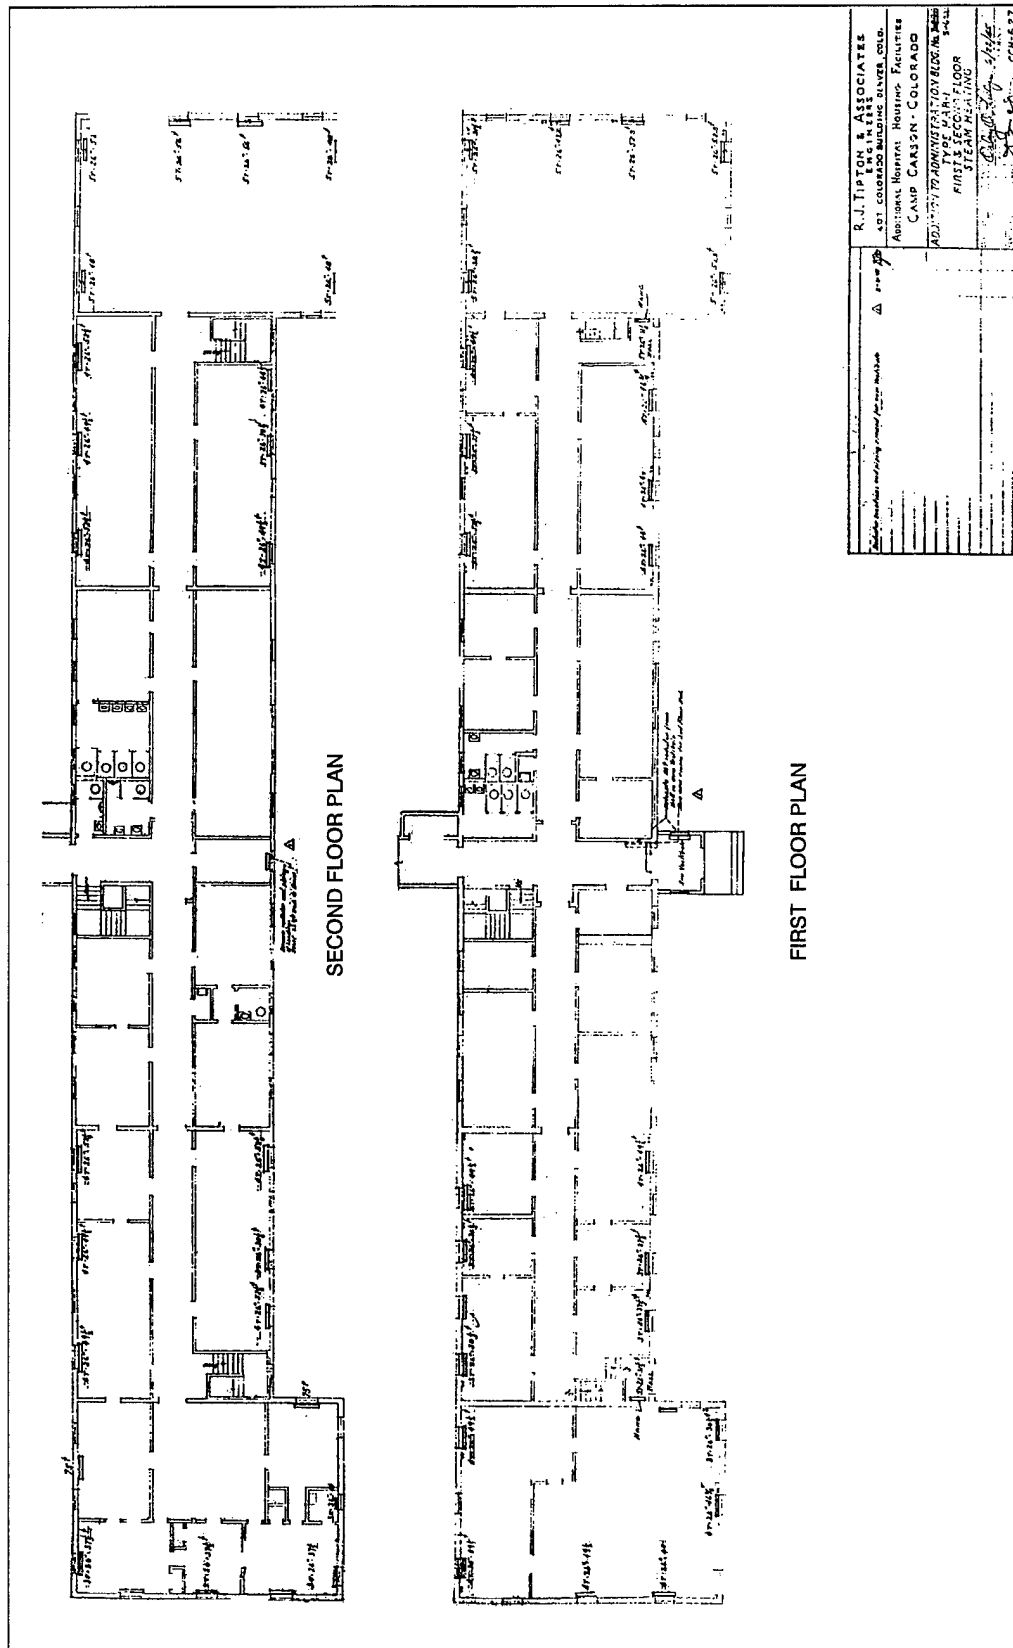
Figure V.2 5EP1778. First- and second-floor heating plans for Building S6225, Administration Building, CCH Series, Sheet 5.27.

Heat is supplied to Building S6225 through metal steam grills (radiators) fed by the OHC's central heating plant. Steam pipes run underground and in the crawlspaces of the building and corridor. Air conditioning units were installed in S6225 in 1993. Sprinkler heads from the original fire sprinkler system protrude through the dropped ceiling tiles.

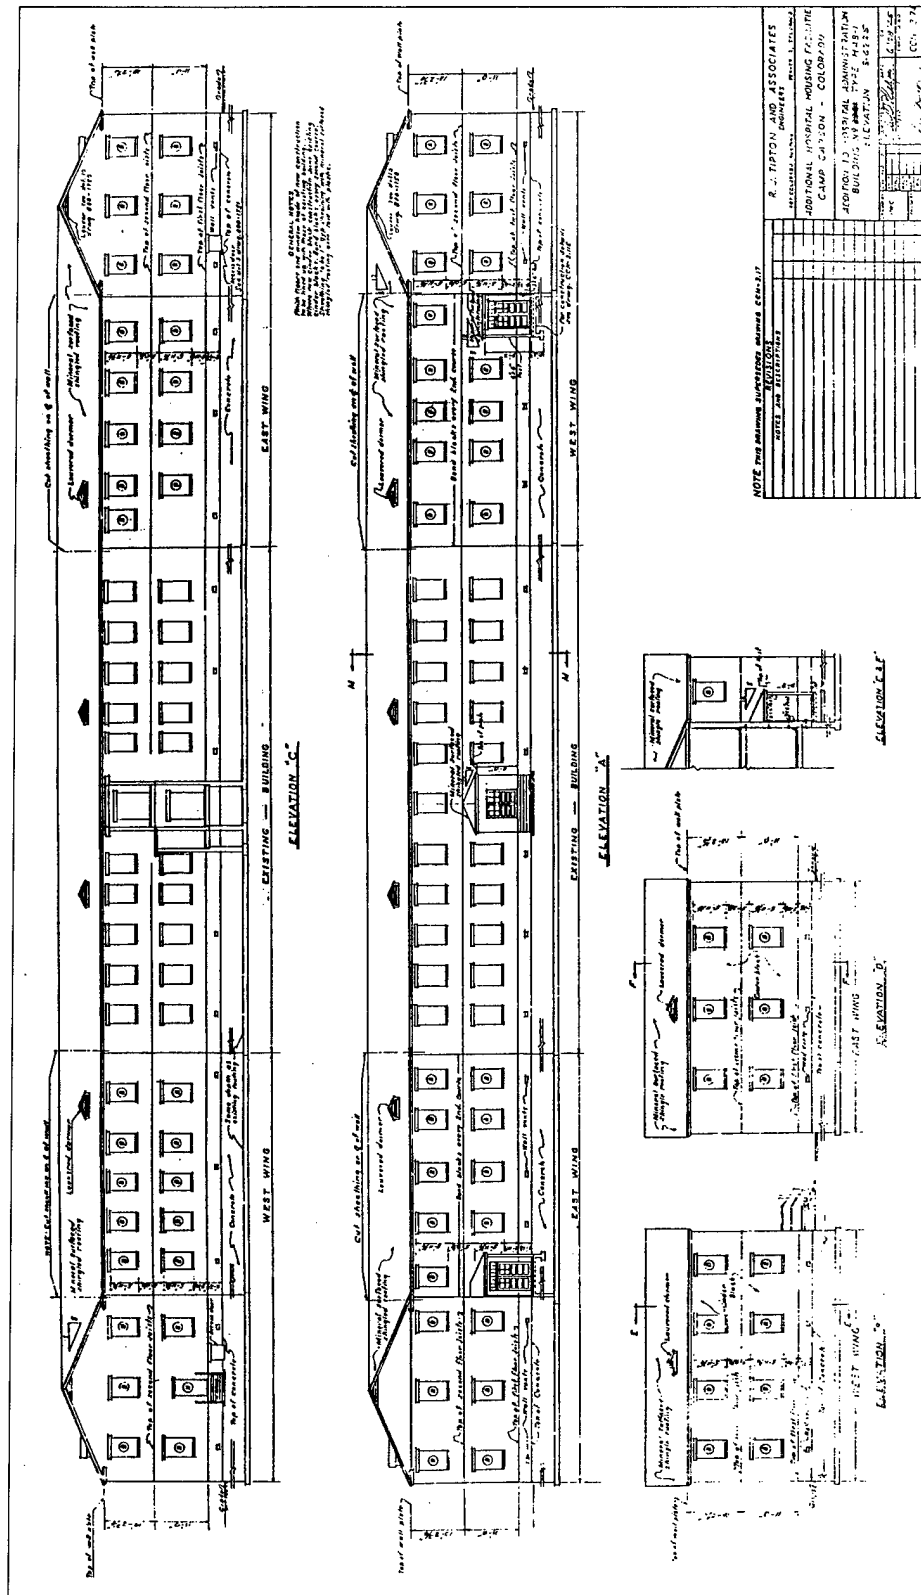
Figure V.3 SEP1778. Elevations for Building S6225, Administration Building, CCH Series, Sheet 3.74.

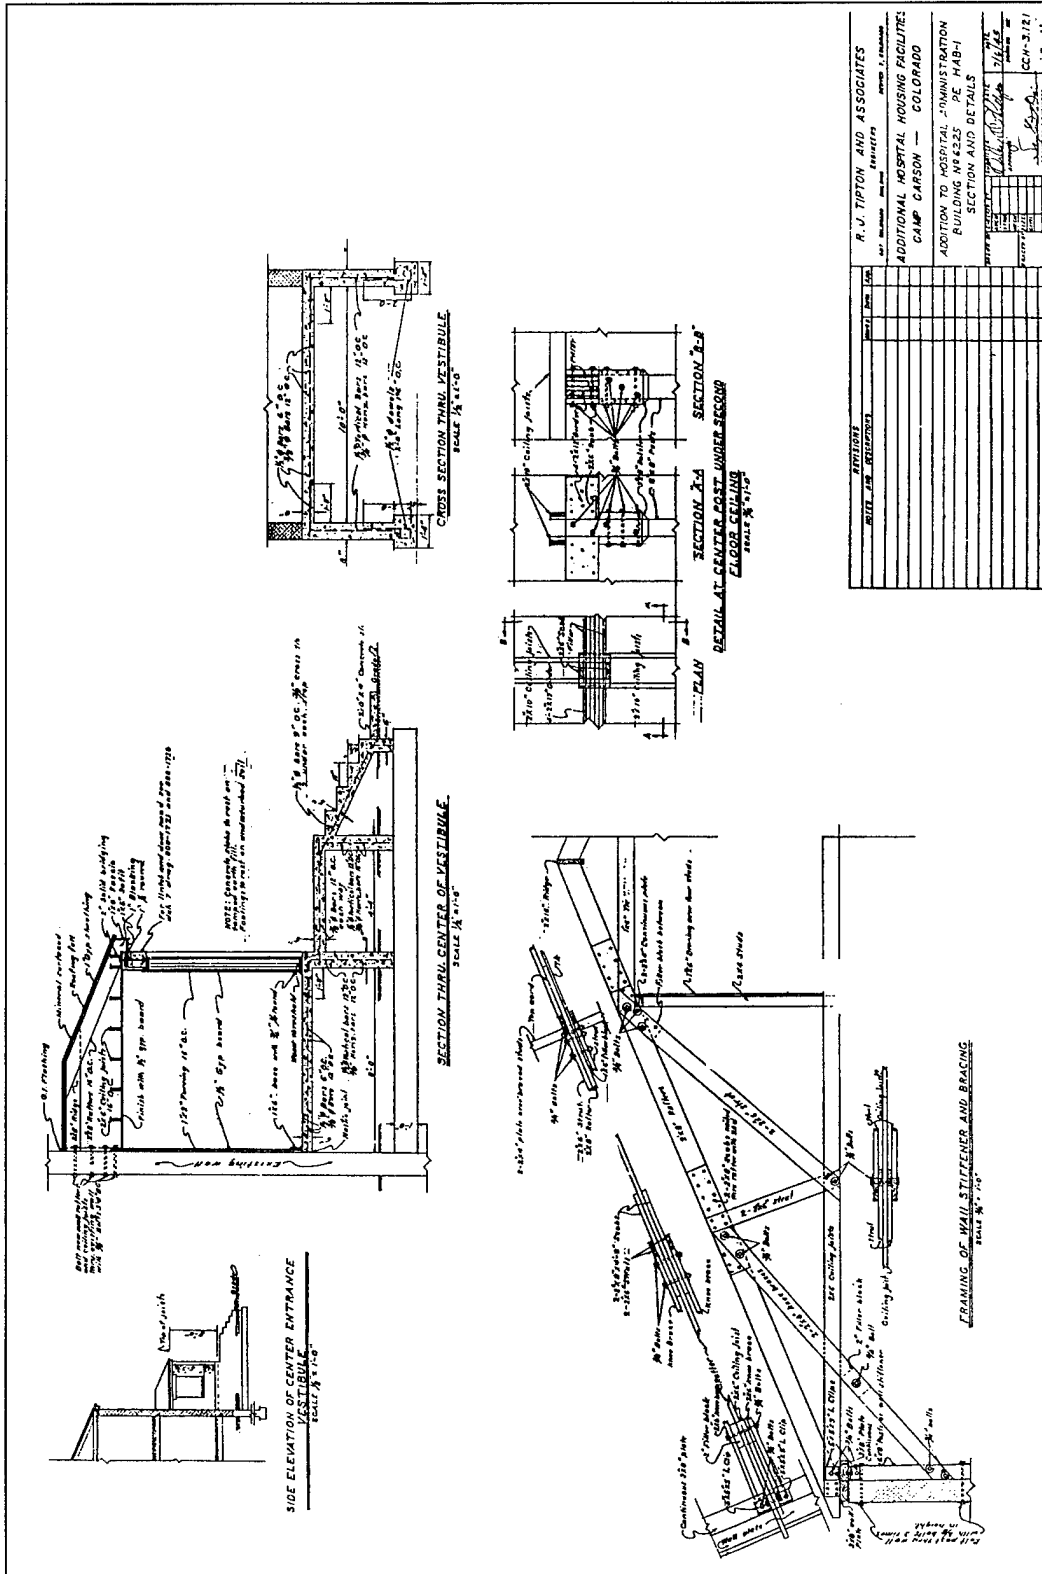
Figure V.4 5EPI778. Section and details for Building S6225, Administration Building, CCH Series, Sheet 3.121.

The structural system of S6225 consists of load-bearing cinder block exterior walls, and piers. The end stairwells are fully enclosed by cinder block walls. The east and west (gable) walls of the original construction remain, effectively dividing the length of the building into three structural volumes. The floor system is wood-joist construction. Joists bear on interior, built-up longitudinal beams. The second-floor beams transfer their load to the foundation piers via solid wood pillars. Floor joists are covered by diagonally laid, tongue-in-groove subflooring, and finish flooring. The roof is supported by wood-trussed rafters that bear on the perimeter walls.

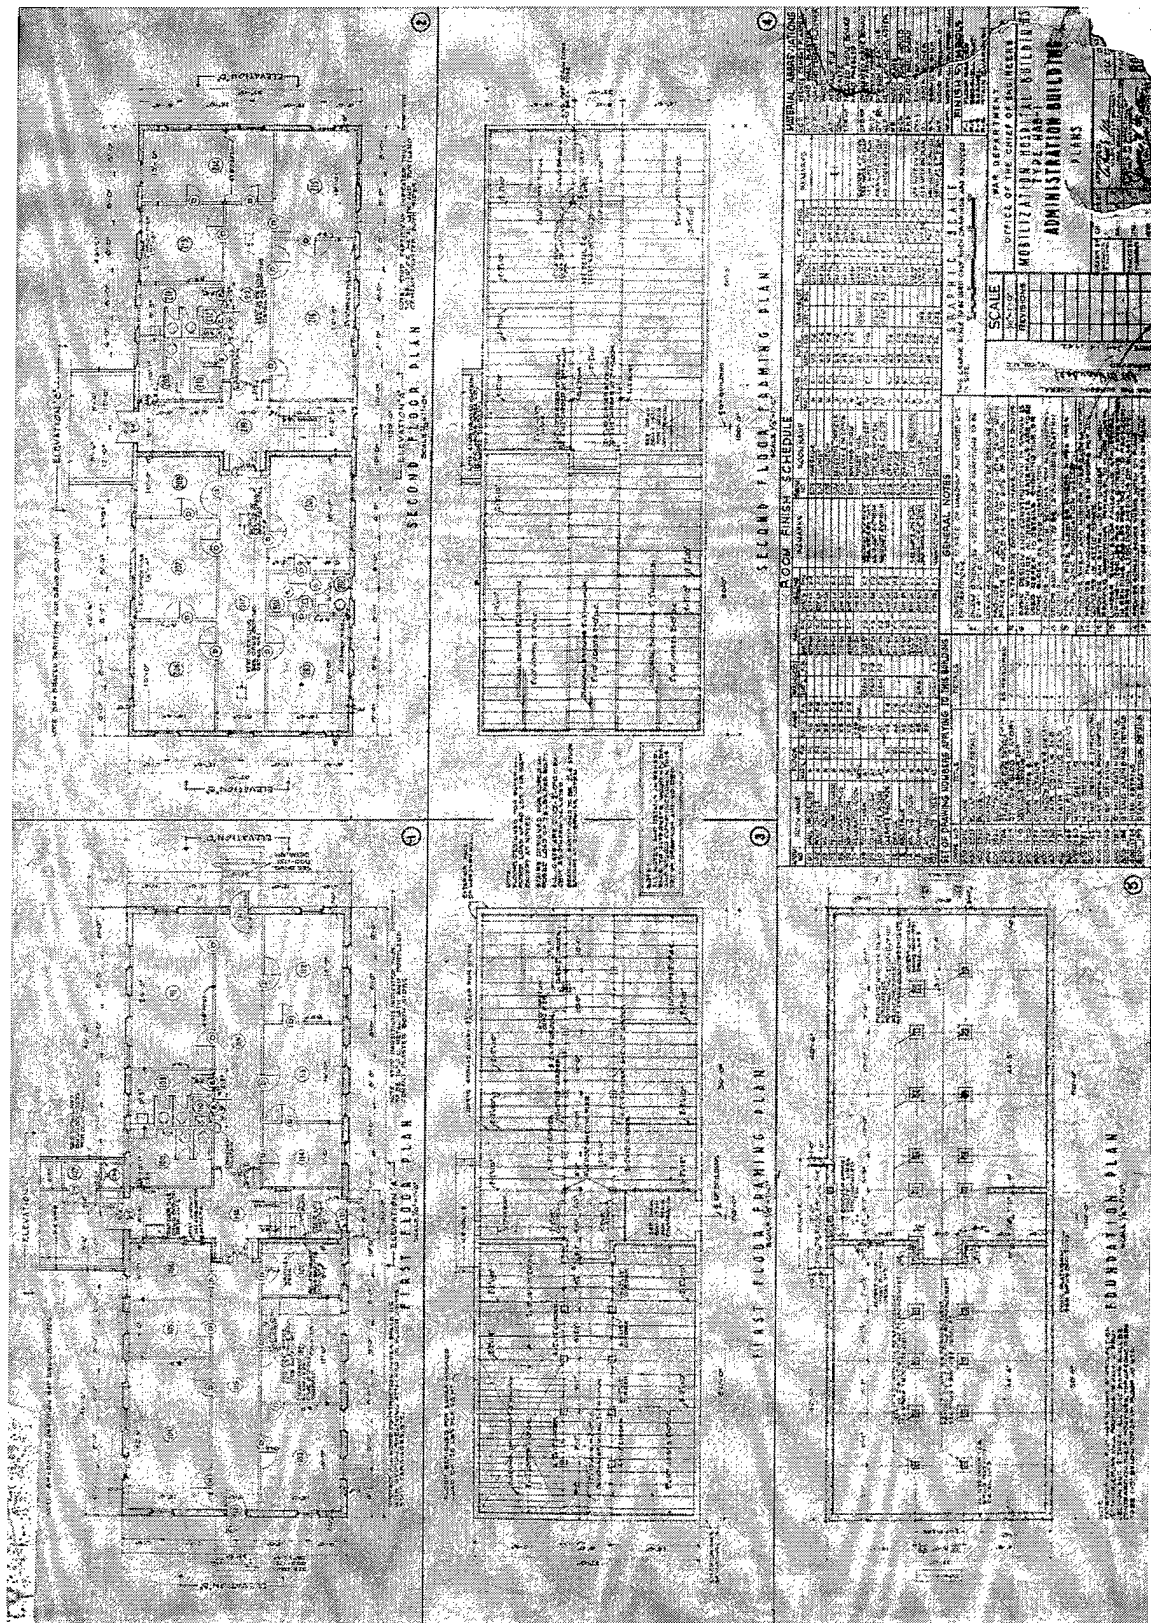
Figure V.5 5EP1778. Framing, foundation, and floor plans for Building S6225, Administration Building, 800 Series, Type HAB-1, Plan 800-2032.

The foundation consists of continuous poured-concrete foundation walls and piers. The foundation walls are one foot thick and rise from the footings to approximately 1' above grade. A small offset near the building's junction with the corridor originally held a hot potable water tank. This water was heated by the complex's central steam heating lines. It is not known if the system is still operational.

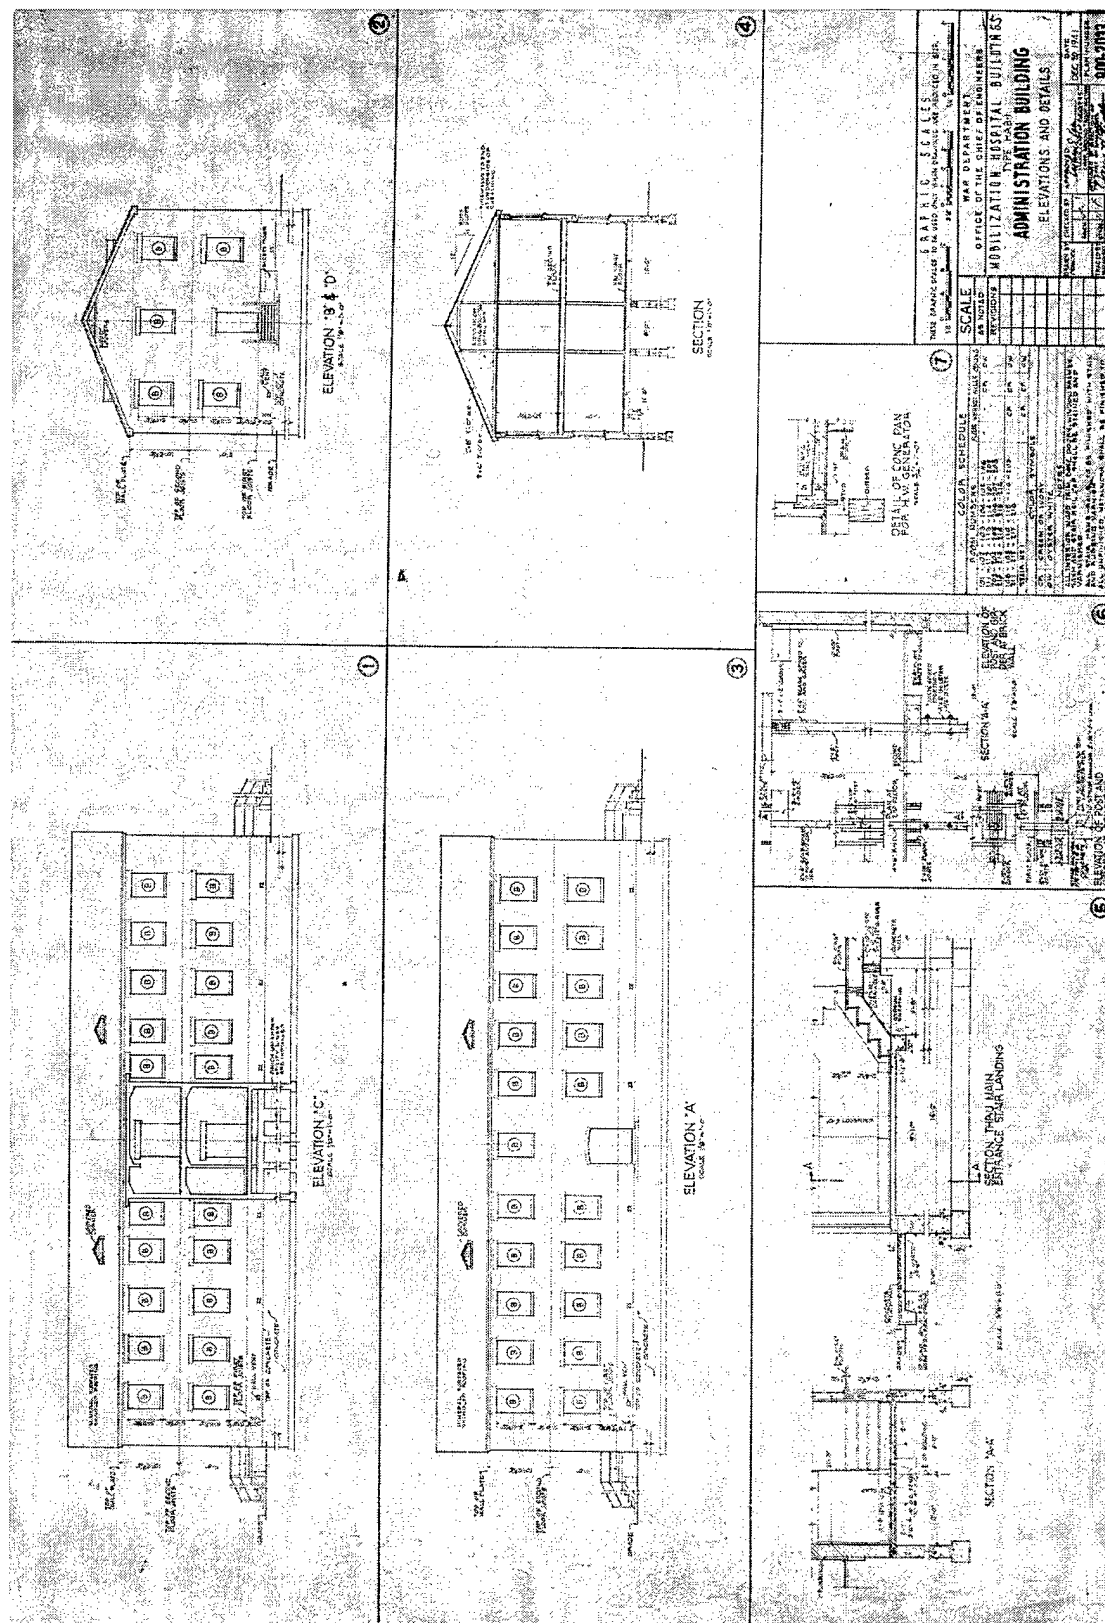
Figure V.6 SEP1778. Elevations and details for Building S6225, Administration Building, 800 Series, Type HAB-1, Plan 800-2033.

The building's gable roof is moderately pitched and supported by wood-trussed rafters. Four louvered triangular eyebrow dormer vents are symmetrically arranged on the north- and south-facing slopes. One similar dormer vent graces each of the east- and west-facing slopes. Additional louvered vents sit under the gable peaks. The boxed eaves overhang 6" on the eave sides, and the gable ends have subtle cornice returns at the eave line. The cornice consists of a single 1" x 12" board topped with a strip of crown molding. The original mineral-surfaced shingle roofing has been replaced with three-tab asphalt shingles.

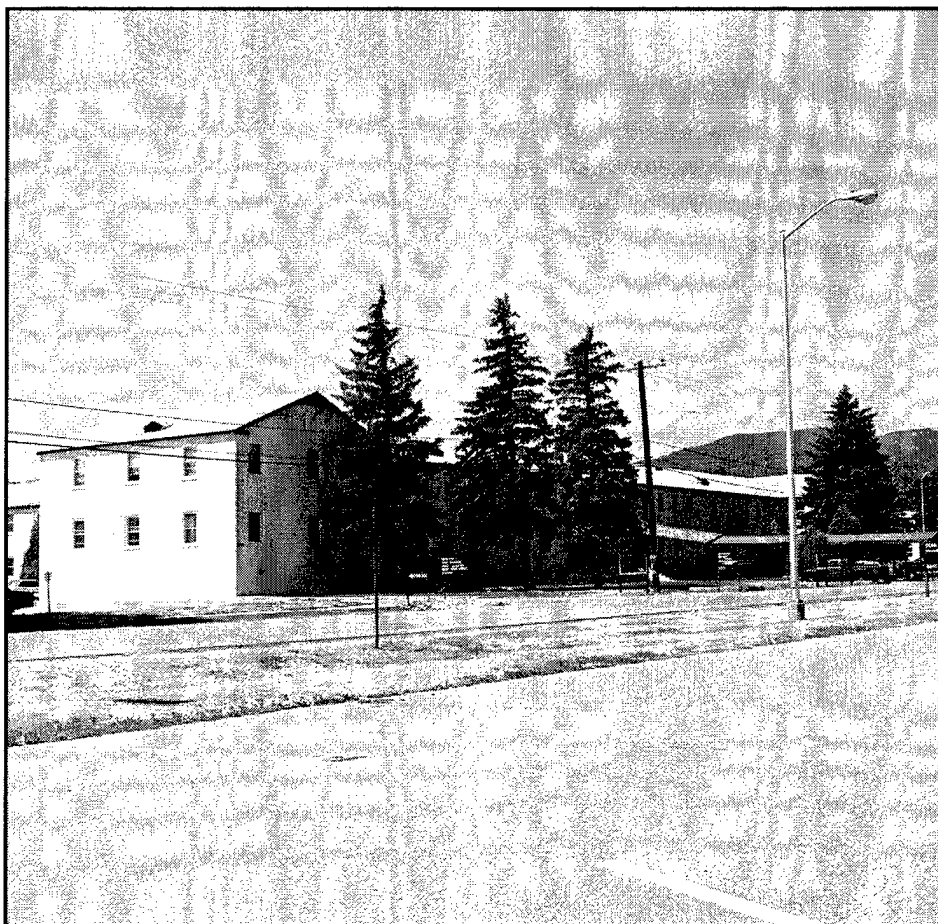
Figure V.8 5EP1778. Building S6225, Administration Building, 800 Series. Type HAB-1. Three-quarter view of north and east facades. Roll 17A, Exposure 9.
